The REMR Bulletin

News from the Repair, Evaluation, Maintenance, and Rehabilitation Research Program

Volume 11, Number 2

Increasing efficiency in a sandbagging operation

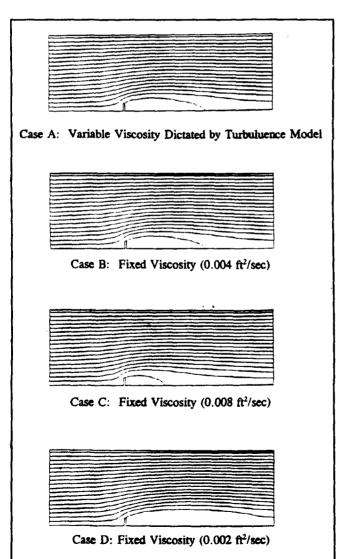
Figure 1. Flow past a dike (streamlines)

constant depth (D) and width (W) was simulated for a spur dike. The spur dike was perpendicular to the channel with a length of W/10. The imposed boundary conditions consisted of a uniform upstream velocity of 1 ft/sec and negligible bottom and side-wall resistance.

This flow was simulated with (Case A) and without (Cases B, C, D) the turbulence model. For Cases B, C, and D, a constant eddy viscosity of 0.004, 0.008, and 0.002 ft²/sec was used, respectively. The streamlines (particle paths) for all four simulations are shown in Figure 1. For thin dikes in shallow smooth channels, a separation length of about 1.2W has been reported (Rajaratnam and Nwachukwu 1983). As the flow approaches the dike, it accelerates around and separates off the dike tip. Considerable turbulence is generated at the tip of the dike, affecting the recirculation behind the dike. The length of the separation bubble

for Case A was 1.1W, which is slightly shorter than the observed length. The flow field for Case B using a constant eddy viscosity was quite close to that in Case A, with about the same reattachment length. However, if the viscosity is increased or decreased by a factor of 2, the flow field is considerably different, as shown in Cases C and D. The reattachment length varies from 0.5W for Case C to more than 2.0W for Case D.

This simple study illustrates the importance of the imposed eddy viscosity on the resultant flow field. Simulations using a constant eddy viscosity can yield flow fields quite similar to the variable eddy-viscosity solution determined from the turbulence model. However, the question remains, whether a field engineer (or anyone else) can reliably guess the appropriate eddy viscosity for a wide range of flow conditions involving single or multiple dikes of various lengths.

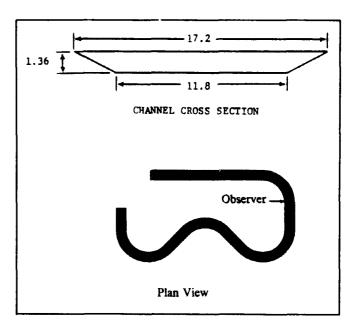
Figure 2. Riprap test facility

To test the performance of STREMR in simulating the depth-averaged velocity field in a curved channel, numerical model results were compared with observations of flow conditions made in a laboratory facility. The Riprap Test Facility located at WES is a trapezoidal channel with four bends and two reversals in curvature. The plan view and channel cross section are shown in Figure 2. The inflow is from left to right, and the arrow (plan view, Figure 2) indicates an observation

station and the orientation of the observer. The flow distribution throughout this complex series of bendways was observed for a flow rate of 49.5 ft³/sec and a Manning coefficient of 0.026. These measurements were averaged over the depth and compared with numerical predictions of the flow field.

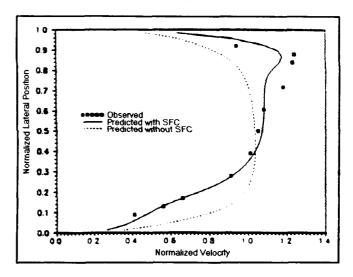
Figure 3. Observed and predicted normalized velocity distribution downstream of a 90-deg bendway

The numerical predictions of the flow with and without secondary flow correction (SFC) illustrate the improvement in predictive capability provided by the curvature correction in the STREMR model. The migration of the maximum velocity to the outside of the first 90-deg bendway is shown in Figure 3. The maximum velocity occurs near the toe of the sloped outer bank. Without the secondary flow correction, the maximum velocity tends toward the inside of the channel. Similar results were found throughout the remainder of the test channel. Without a correction for secondary flow development in curved channels, numerical models will generally underestimate the currents along the outer bank. This could have serious consequences for the design and operation of river engineering works.
